Landslide Risk Evaluation and Mapping - Manual of Aerial Photo Interpretation for Landslide Topography and Risk Management -

Abstract

Key words : Landslide, Risk evaluation, AHP, Photo interpretation, Inspection record sheet

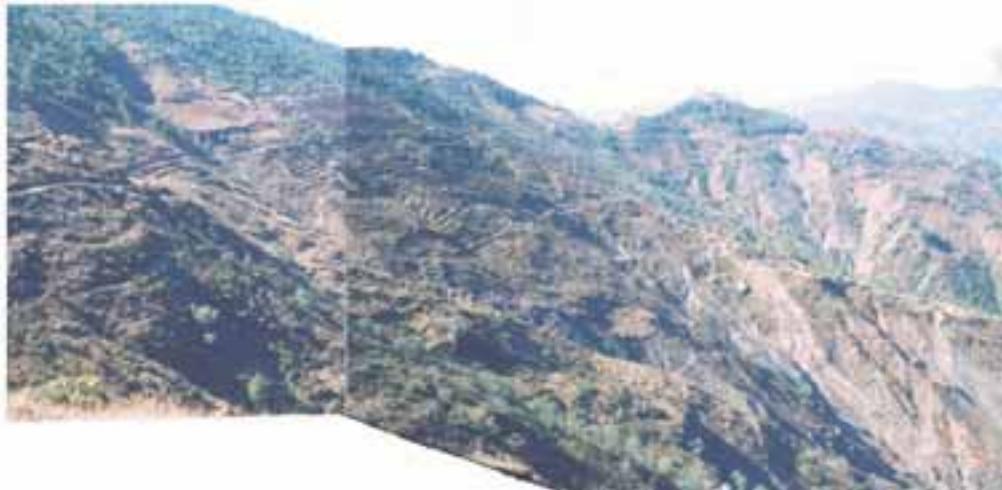
Fig. 3.2 A view of Chisapani landslide at the uppermost Agrakhola watershed in the Central Middle Mountain range of Nepal. This is a very old landslide which reactivated in 1993 disaster and is still in active condition. Several cracks are developing on the head of the landslide, several active gullies are developing in landslide body and the new scarps are extending upward collapsing the unstable blocks of landslide (Photo view is from east to west).

Fig.3.2 and **Fig.3.3** shows the Chisapani landslide which is located in the uppermost watershed of the Agra khola in the Makwanpur district of Nepal is the example of the old landslide in the middle mountain which reactivated in July 1993. This landslide killed 4 people and damaged 32 houses in the Chisapani village and debris flow and flood damaged the Prithivi high way at downstream. Although some people have already migrated from the landslide areas to other safe places like Hetauda and Terai, however most of the people are still living on the vulnerable area of the landslide. According to the version of local people in the landslide area, this landslide reactivated in 1993, 1954, 1970

and 1993. However no any recorded evidences has been found of reactivation of landslide in the past. Several old and recent scarps and linear tension cracks are clearly defined in the head and the landslide body which indicates that these landslides are still in active condition. All the agriculture lands (Bari and Khet) in the landslide area have been still using which is very high risk for the future reactivation.

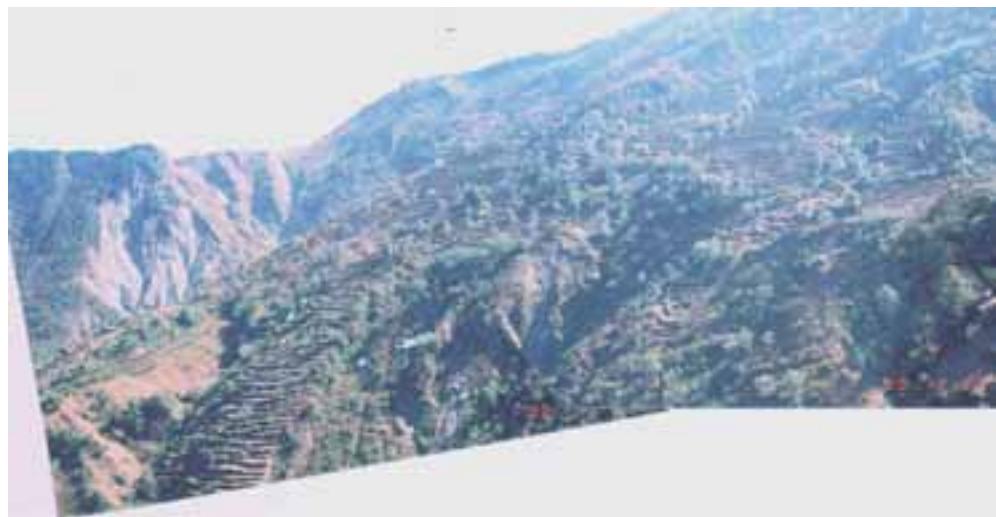
Fig. 3.3 A view of Chisapani landslide at the uppermost Agrakhola watershed in the Central Middle Mountain range of Nepal. This landslide is very old and is still in active condition. (Photo view is from west to east).

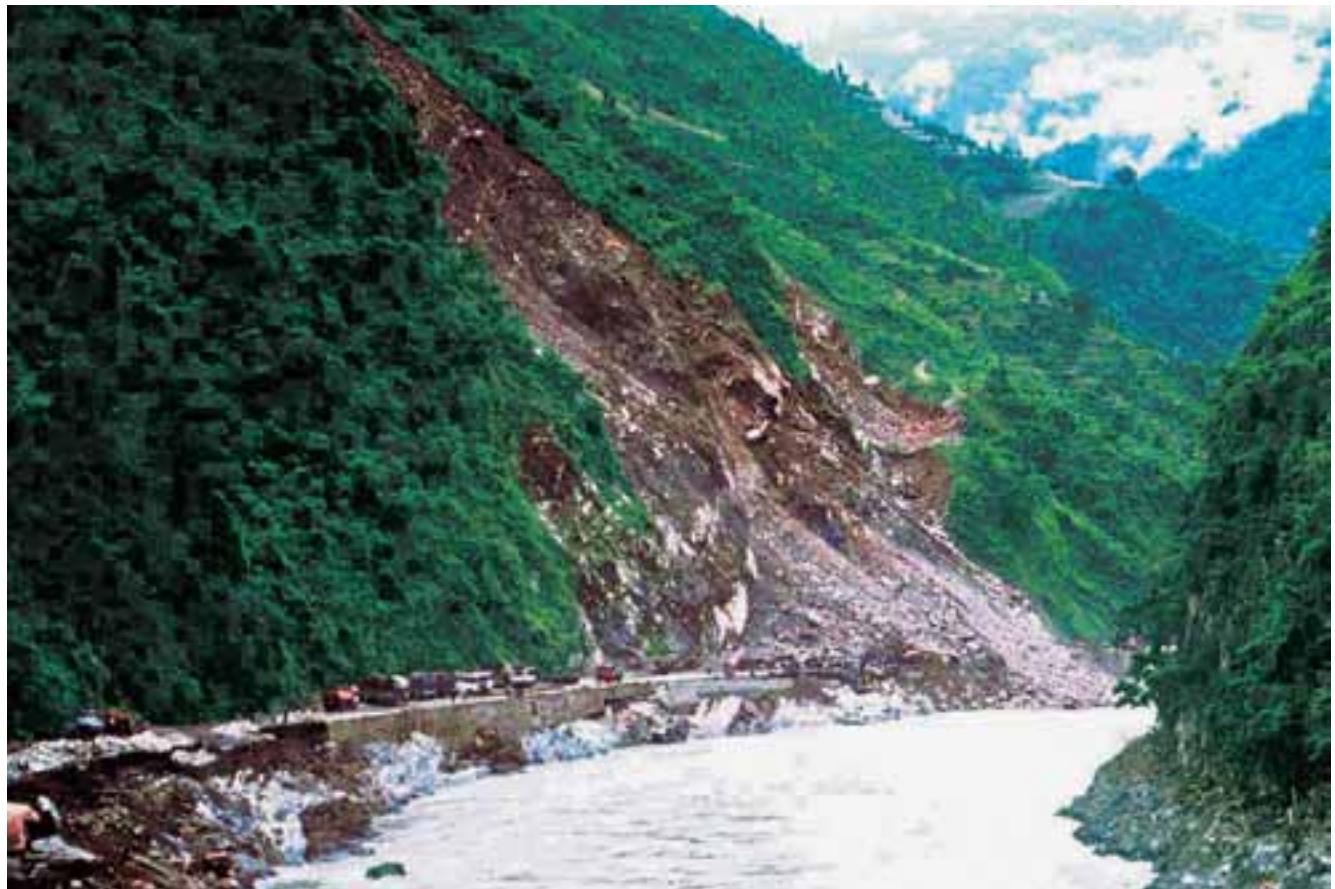
Fig. 3.6 An over view of Jogimara landslide which damaged the Prithivi Highway (Muglin to Kathmandu road) in the Middle Mountain of Nepal. This photo was taken just after disaster in July 1993.

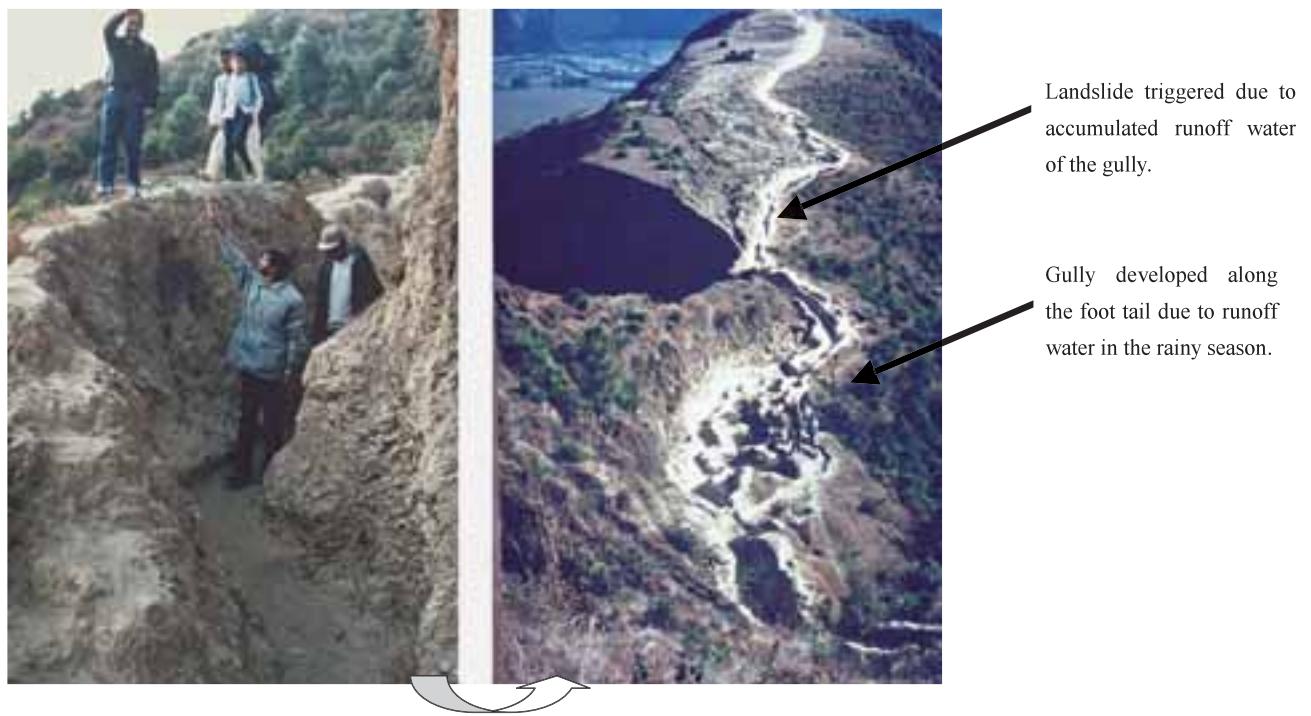
Fig. 3.7 A view of foot trail at the Middle Mountain of Nepal, this foot trail changed to a gully and at the end the gully changed to a landslide due to accumulate surface runoff during the monsoon.

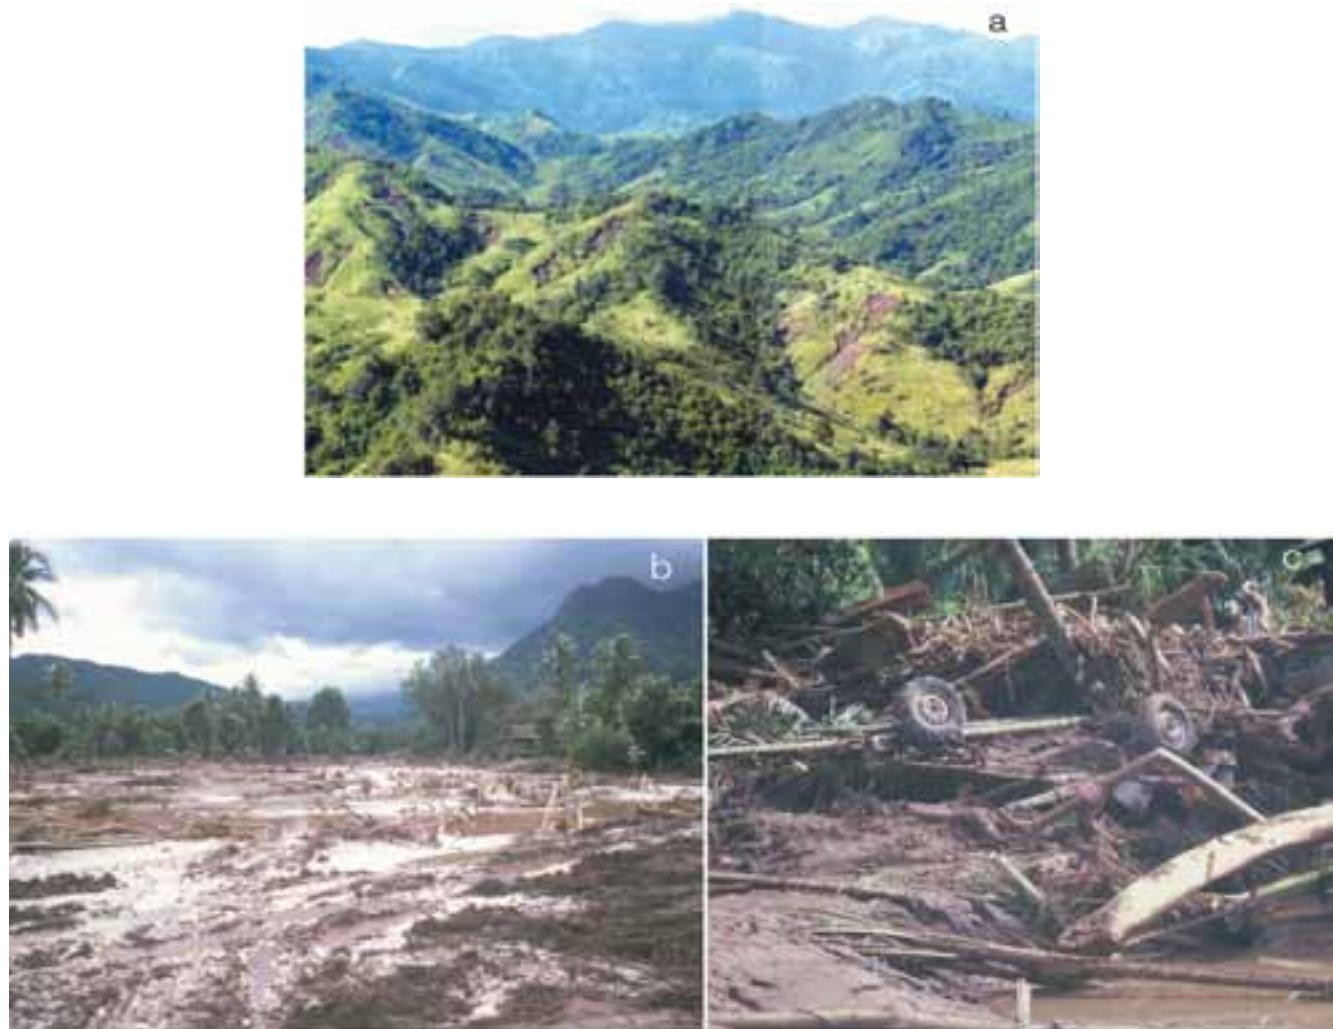
Fig. 3.10 Landslide hazard hit two small villages where located by the river at the mountain margin of Lomsak basin, central Thailand. a; A great number of erosion landslides (scars) occurred at the poor land cover watershed. b; Flash flood washed away houses and lives. c; The debris only consist of fine materials and logs.

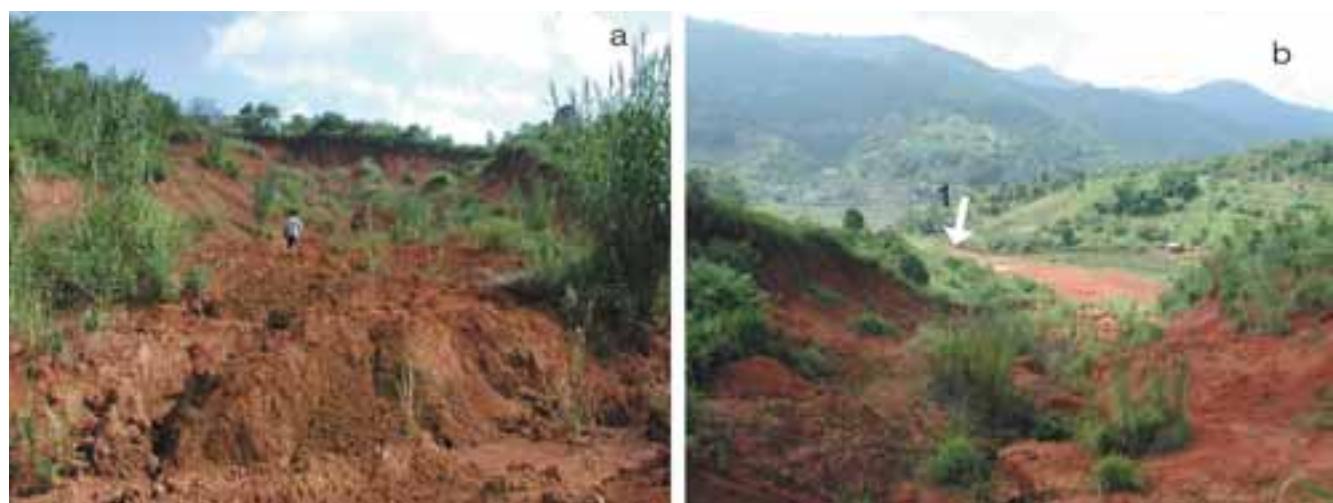
Fig. 3.11 Rapid flow type landslide at the foot slope near Chiangmai City northern Thailand. a; The source area is located at the gentle hill foot slope which consist of deeply weathered andesite. b; The slip surface has gentle gradient and the body run and scattered long distance (white arrow is the portion of toe).

Rapid flow type landslide occurred at hill slope near Chiang Mai. The landslide destroyed a gentle hill slope which consists of deeply weathered andesitic rocks. The square of destroyed area reaches about 50m by 100m in the area and main scarp is 10 meters high. The landslide body was quickly transported to the river floor in lower reaches. This material transported about 300meters and thinly deposited, it established a wide flat plain. The trigger of the rapid flow type landslide seems to be the large amount of water infiltrate to the weathering body.

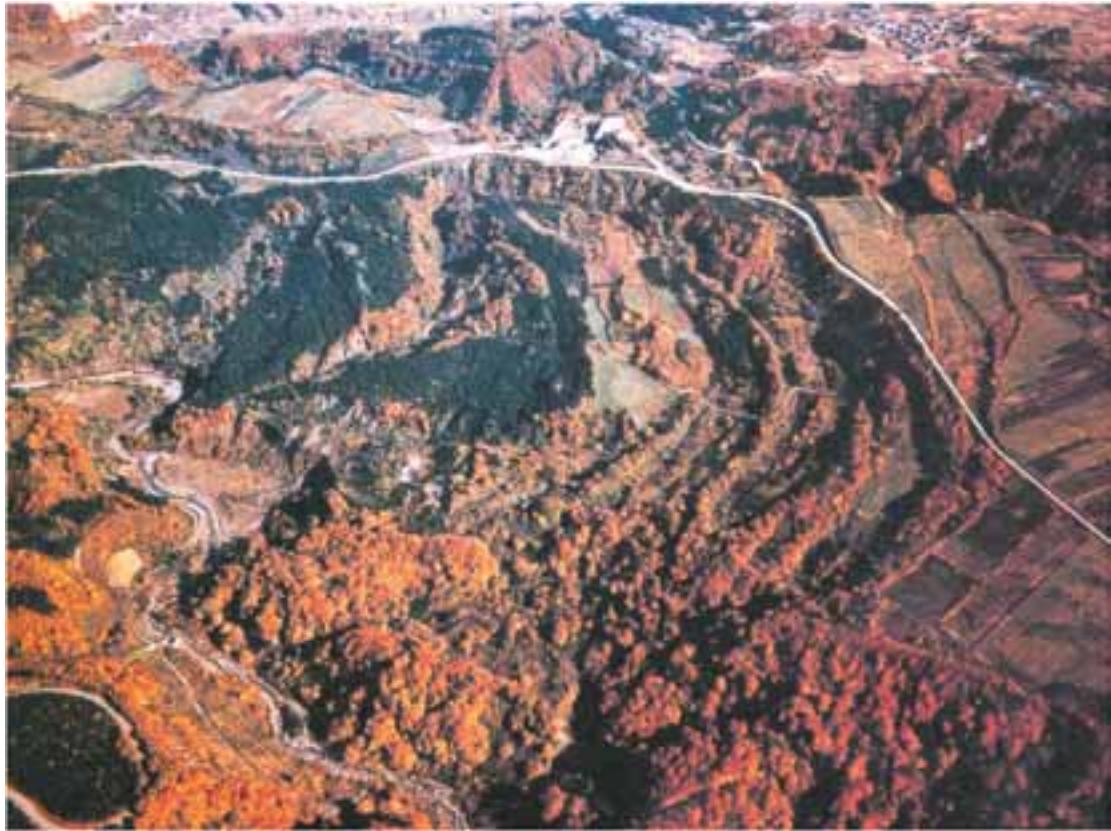
Fig. 3.13 An overview of Sabuta landslide area Yamagata Prefecture eastern part of Dewa Mountains northeast Japan.
(It keeps the clear shape of landslide features and the action occurred at the whole of the topographic area).

Fig.3.13 shows the over view of landslide topography. The Sabuta landslide in Yamagata Prefecture was marked as a large scale landslide topography. There are many scarps in shape of horse shoe and many small cracks in the behind. It is easy to recognize a typical landslide topography from the geomorphic point of view. But, no direct landform deformation has occurred last several decades. So there were several opinions of the risk of reoccurrence of landslide hazard. At the spring 1998, the toe part collapsed to the river and the road at the part of crown subsided gradually. The action restarted by the area of 600m in width and 1,100m in length. The velocity of the surface movement reaches to several meters per year. The surface of rapture revealed at the depth of 70m by borings. Actually a part of the area deformed and slipped down into the river about 50 years ago. 38 lives had lost at that action.

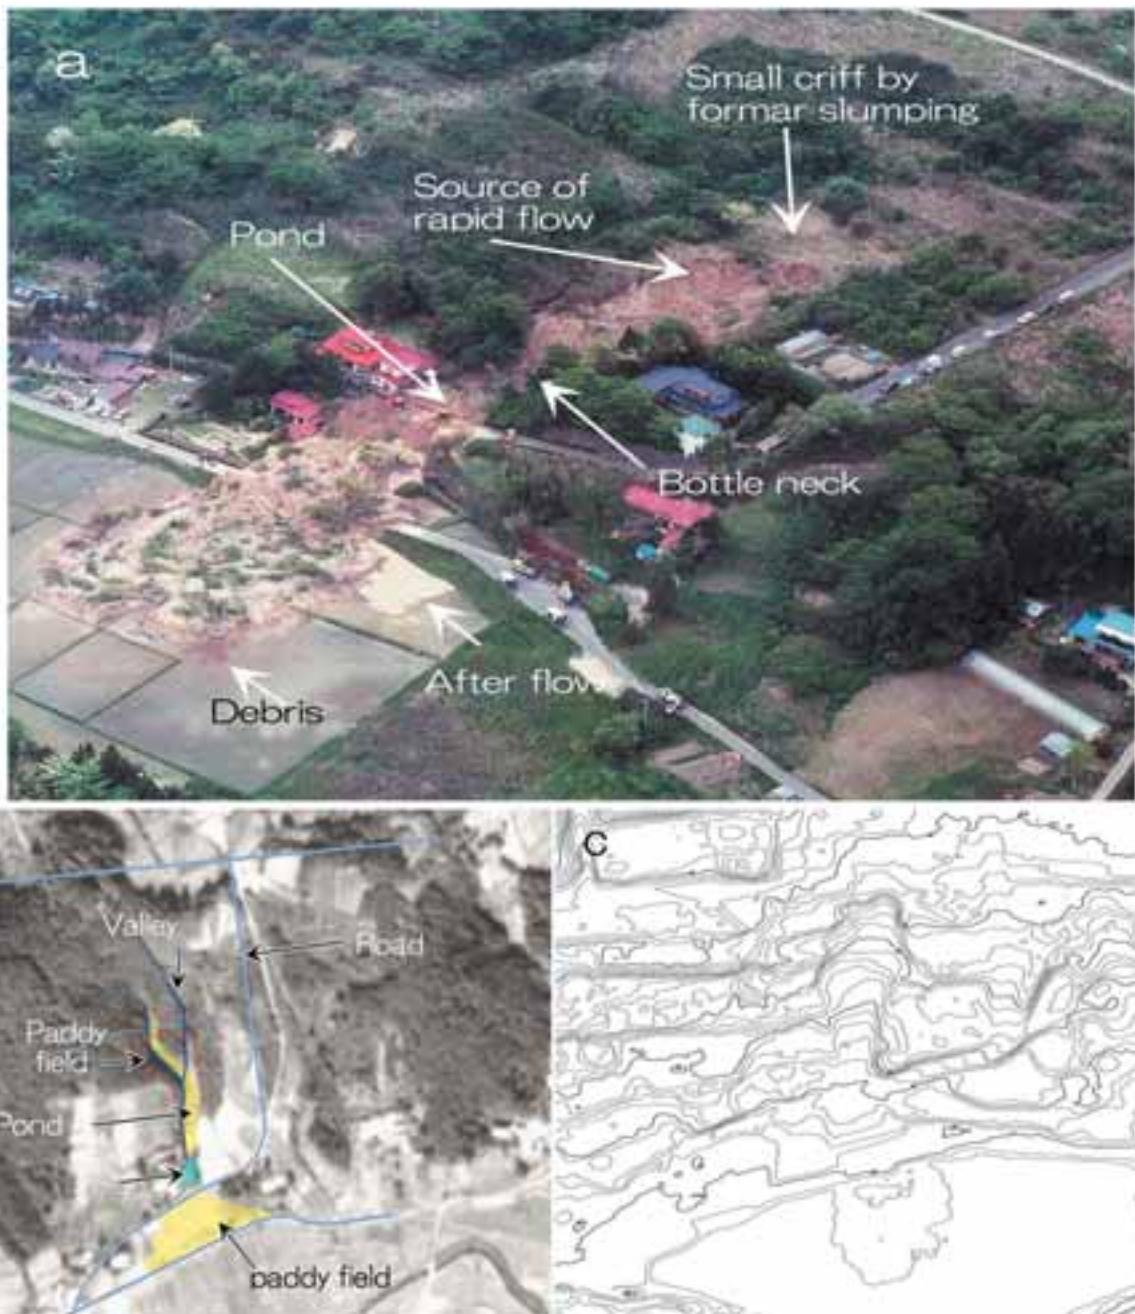
Fig. 3.16 Rapid flow landslide at the artificial reclaimed area by the trigger of earthquake on May 26, 2003 Miyagi Prefecture. a; An overview of landslide area just after the action (The photo is taken by Kokusai Kogyo Co., Ltd.) b; The landslide occurred at the reclaimed valley. The land modification completed 35 years ago for agricultural use. The former topography and land cover such as pond and paddy fields shows the highly potential of ground water. c; The 1 meter contour interval map (The map developed by laser data) shows the clear landslide topographies.

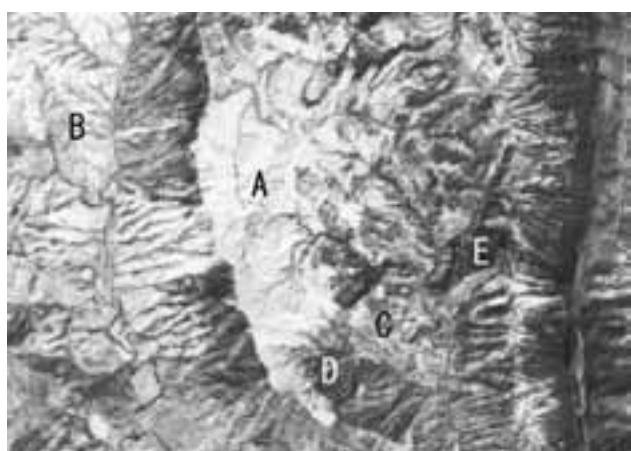
Fig. 4.7 An aerial photograph at mountain side of Lomsak basin Pechabun province, Thailand. The area classified into five levels of land cover. A to C is degraded vegetation area especially A is completely changed to bare or grass land. Tree line can be seen just along the channels. B is the vegetation coverage is slightly higher than A. Although there are many bared stripes or patches that seems as a features of surface erosion. The land cover type A and B, the strength of grasp of soil by tree roots must be reduce and the surface runoff and infiltration getting quickly, it will lead the surface erosion and surface landslide. D and E is still keeps the forest.

a lot of surface failures have occurred near the break line on the sideslope. On the other side **Fig.4.7** displays soil erosion at Pechabun area, in the middle of Thailand. But a clear break cannot be identified in this figure. This suggests that surface failures as displayed in **Fig. 4-7** rarely happen here in geo-historically. However, this picture shows that in the broad area of the slope, the vegetation was strikingly destroyed and the corresponding area became bare and grassed. Thus, it may be possible to predict the potential soil erosion and surface landslide like a Phipun basin at each micro landform unit by means of the classification of micro landform units on slopes.

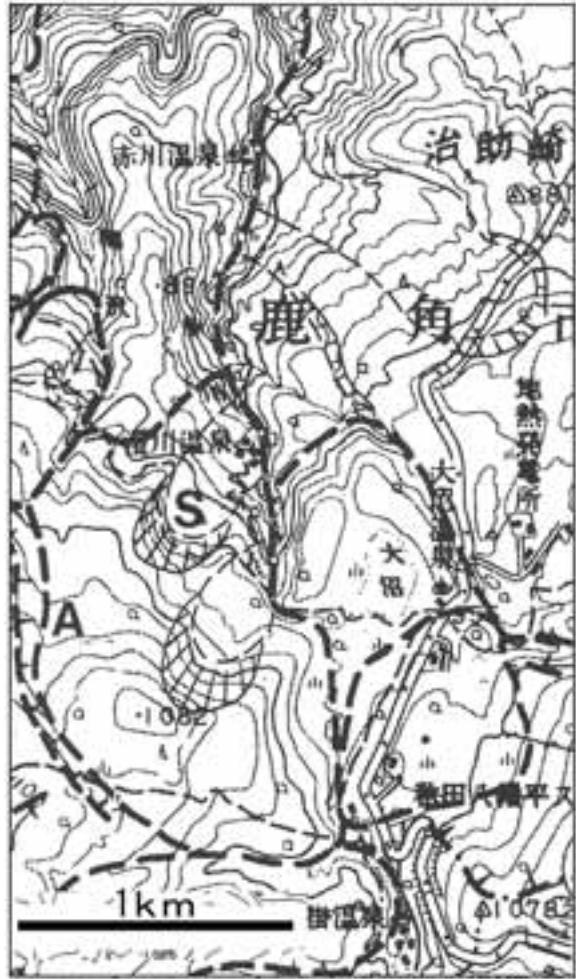
Fig. 5.12 Landslide topography map of the area in Fig. 5.12. The landslide which has mentioned in Fig. 5.12 occurred at the marked place. This is an example the ability of forecast the landslide reoccurrence (after Inokuchi, 1998).

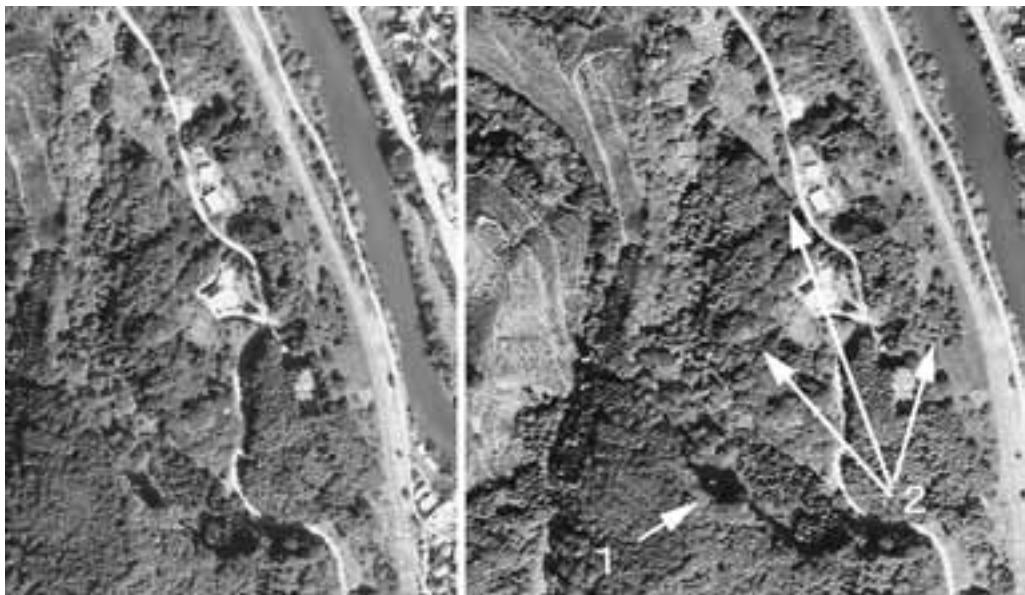
Fig. 6.6.c Separation scarp. Weight value: 2.0.

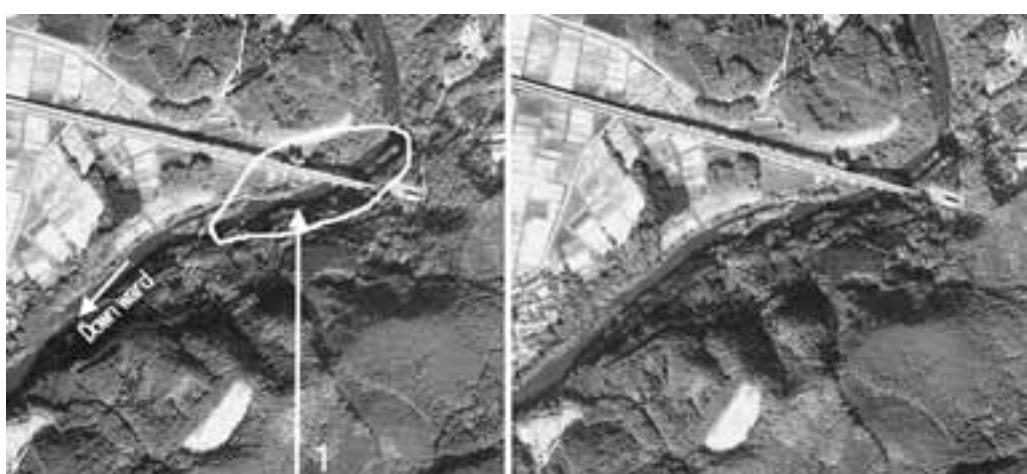
Fig. 6.11.a Landslide body and adjacent environment. Landslide body at lower face to the other near. Increase toward the active condition. Weight value: 8.6.
